# III REHABILITATION AND MAINTENANCE OF EXISTING STRUCTURES

## III.1 INTRODUCTION

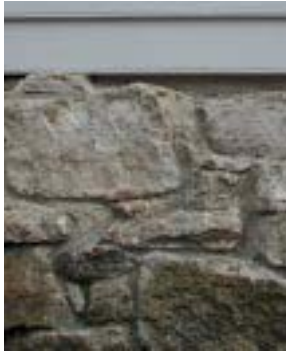
Stone Foundation

Some stone is reputed to have been carried to Chestertown in ship ballast, and the use of English ballast stone has been documented in parts of the Custom House. Other stone came from regional sources, as local stone was scarce. Quarries north of Baltimore provided much of this stone, and some types can be traced to specific locales such as Port Deposit. When replacing old stone in a foundation or wall, it is important to try and match the original materials as closely as possible.

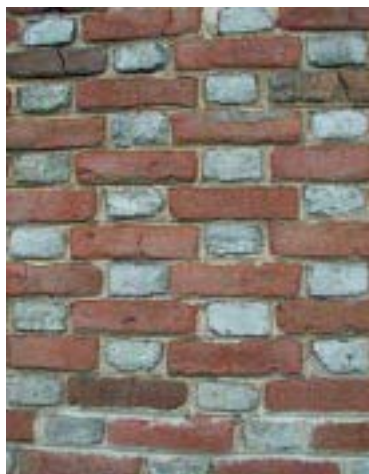
Flemish Bond with  
glazed header bricks

Other important characteristics of masonry are the method of *bonding* (the orientation of bricks or stones in the wall) and the size and shape of mortar joints. A successful rehabilitation project must match these characteristics. Bricks can be laid lengthwise in a wall or positioned so that only the end shows. If the long side of a brick is visible, it is called a *stretcher*. If only the end shows, it is referred to as a *header*. A single row of bricks is called a *course*. A common method of laying bricks in the 18<sup>th</sup> century was *English bond*, in which courses were alternately comprised of all headers and all stretchers. A fancier and more expensive approach was *Flemish bond*, in which a single course alternated headers and stretchers. In the next course up, headers were positioned so that they were directly above the center of a stretcher in the lower course, forming cruciform pattern of bricks. In early kilns, some bricks could be produced that had a beautiful bluish glaze on them. If only glazed headers were used, a diamond pattern could be formed

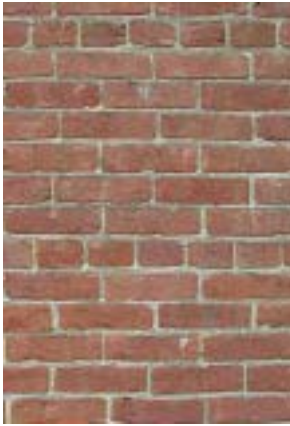
Common Bond

on a wall; other geometric patterns also could be produced. Yet another expensive 18<sup>th</sup> century bond was *header bond*, in which all bricks were laid as headers. The greater expense of Flemish and header bonds meant that they often were used only on the public facades of buildings; English bond was used elsewhere. By the end of the 18<sup>th</sup> century, Flemish and header bonds became less common (although Flemish bond saw a resurgence in the Neo-Classical style and may be used on public buildings today). Instead, masons shifted to *common* or *American bond*. Here a single course of headers was laid, followed by several courses of stretchers. Every sixth course, for example, may be comprised of headers. Although usage was highly variable, the number of stretcher courses to headers seems to have increased as time passed.

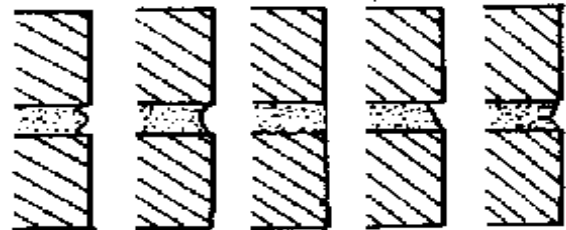
Grapevine, Concave, Flush, Raked and V mortar joints

Mortar joints on brick and stone walls can take a variety of forms. In general, mortar joints were thicker on older walls, simply because of the irregularities in hand-formed brick. As bricks became more uniform, thinner joints could be used. To disguise the thickness of early joints and make them appear more regular, masons sometimes scribed or tooled a groove through the center of the joint. Other types of joint treatments are shown at right, and rehabilitation projects should strive to match the original treatment. With older brick buildings, great care should be taken not to damage the brick, especially the outer surfaces, as this will expose the softer core to decay.

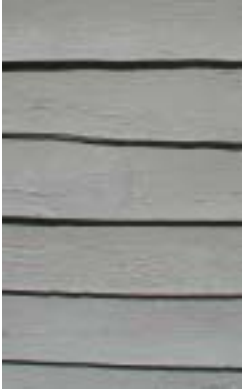
Beveled lap siding

The most common wood siding is known as *clapboard*, consisting of long horizontal boards that are nailed to the building's frame from the ground up. Only the tops of the boards are nailed, and the bottom of each board covered the top of the course below it. This method of nailing helps the siding to shed water. The exposed width of each clapboard (the "reveal") is an important characteristic of each individual building, as is the shape of the boards. In *beveled* siding, clapboards are thinner on their upper edge, whereas boards of equal thickness are known as *simple-drop* or *colonial* siding. In either case, the bottom edge could also be *beaded*. In *shiplap* siding, the edges are rabbeted and nailed so that the siding is flush. Sometimes the upper edge of such boards is also routed out or milled to produce what looks like a shallow horizontal groove between the boards, sometimes referred to as *V-rustic* or *German lap* siding.

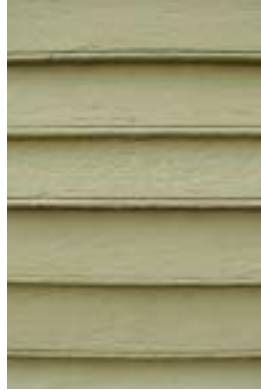
Beaded siding

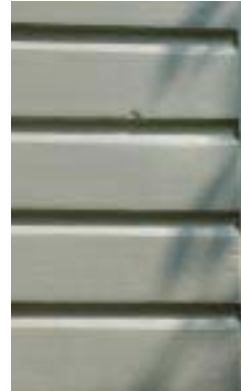
German lap siding

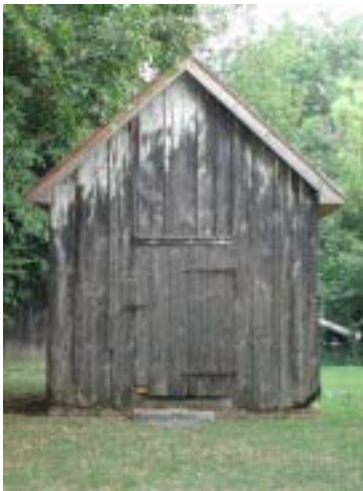
Outbuilding with board and batten siding, Mill Street

Other techniques included *board-and-batten* siding and *shingling*. In board-and-batten siding, boards were nailed onto the frame vertically. The joint between boards was then covered by a much smaller vertical strip of wood referred to as a batten; this prevented the entry of moisture. Board-and-batten siding is not common in Chestertown. Shingling, on the other hand, is more frequently seen. Sometimes these were used to clad an entire structure. Elsewhere, shingles were used in conjunction with other types of siding to produce the complex surfaces and textures sought in Queen Anne style buildings. Such houses often made use of clapboard on lower stories or the first and second stories, while shingles covered gable ends, towers, or upper stories. Shingles could be cut in a variety of patterns, including rounded bottoms that produced a fish-scale effect. In the past, wood shingles were sometimes installed over existing clapboard to avoid the maintenance of painting.

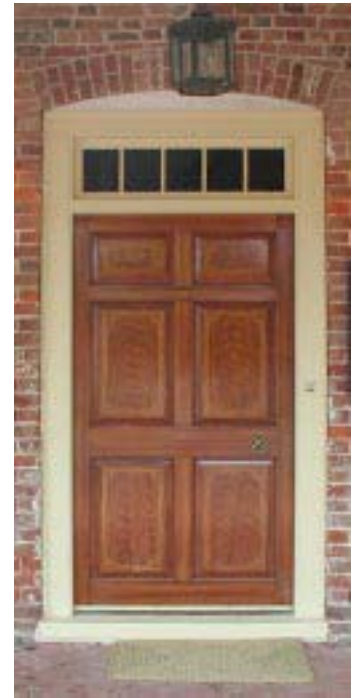
Front door with transom

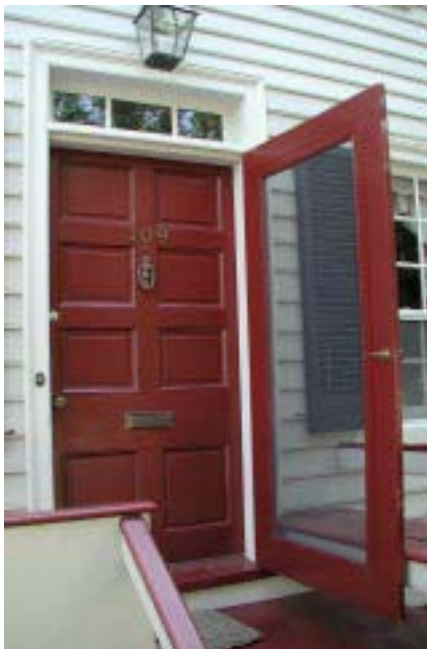
Doorway with appropriate storm door

Screen doors allow the solid doors to be left open during milder months, offering limited security and insect protection for the occupants, while allowing air and light into the entry-hall. Care should be taken when considering the installation of screen doors, however, since some architectural styles were not designed to incorporate them.

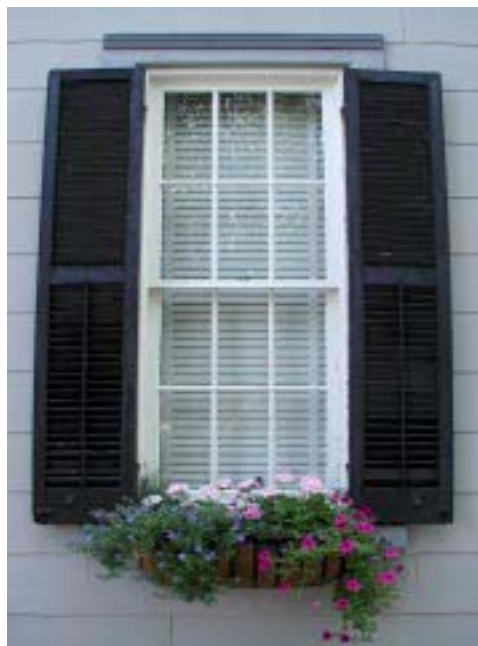
Sash window with louvered shutters

Installation of shutters in locations where they did not exist historically is inappropriate. If replacement becomes necessary, the replacement shutter should match the original in size, scale, detail, thickness, and hardware. Shutters should always be mounted to the window frame, not into the adjacent siding.

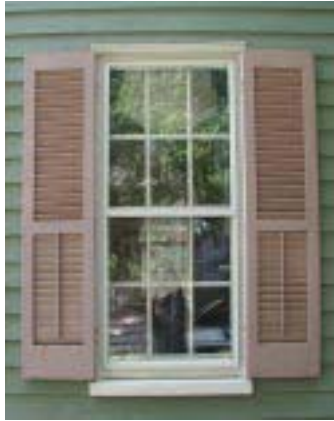
Storm window properly installed

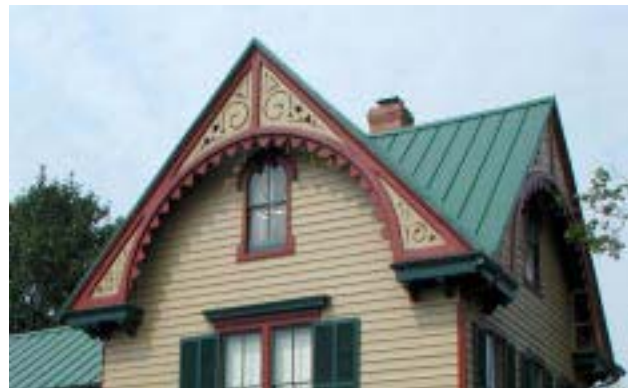
Detail of Boyd House showing metal standing seam roof

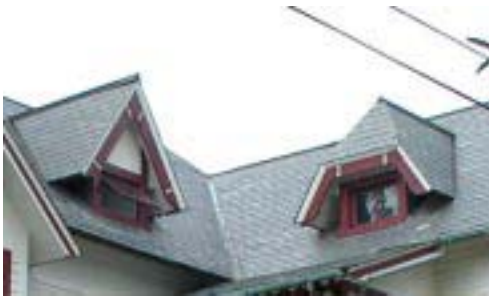
Detail of Pearce House showing slate roofing

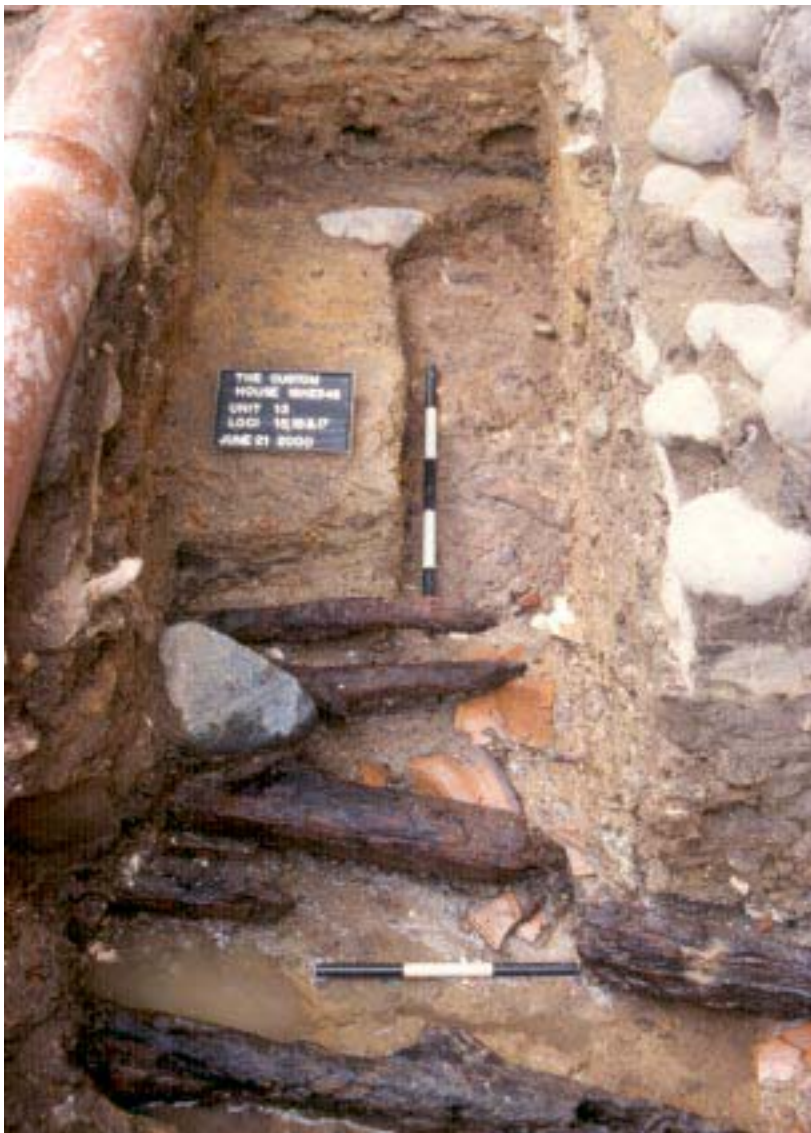
Excavation at Custom House showing oak bulkheading and redware pottery
